PART I: SEPTEMBER 11, 2001

Chapter 1

NEW YORK CITY'S WORLD TRADE CENTER

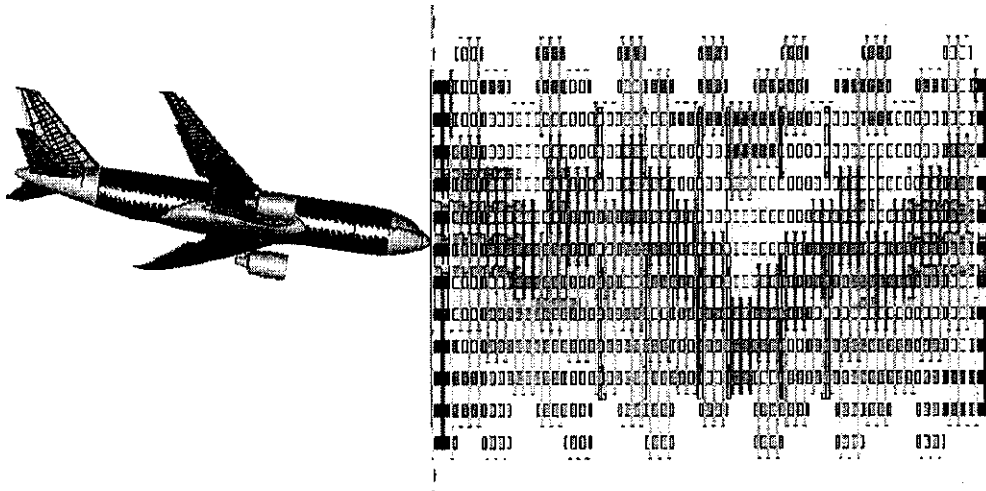
At 8:46:30 a.m. EDT, five hijackers flew American Airlines Flight 11 (AA 11) with 11 crew and 76 passengers into the north face of WTC 1 (Figure 2-1).

Figure 2-1. Simulated impact of American Airlines Flight 11 with WTC 1.

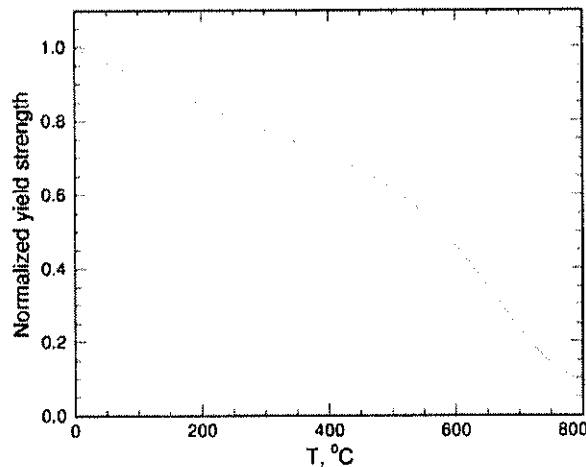
Figure 2-9. Temperature dependence of yield strength of structural steel as a fraction of the value at room temperature.
